Reserve Study Level II

Prepared for Lakemoor Community Club

2023 Fiscal Year

Prepared by CEDCORE, LLC

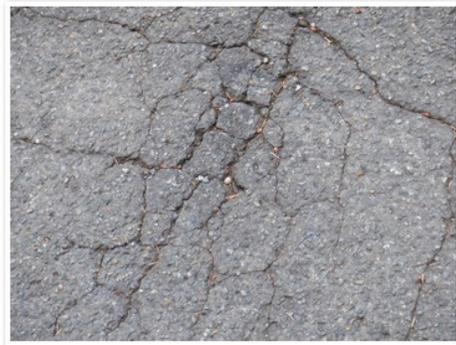
Site/Grounds - Asphalt: Sealcoat, Crack Filling and Patching

Condition: Assorted Condition

Generally fair condition of asphalt surface with some localized areas that are dry and faded. We recommend regular seal cycles be completed to maximize the life of asphalt. Seal coat and crack filler protects against damaging elements, such as oil, water, UV, etc. As routine maintenance ensure that oil spills are promptly cleaned and drains and grates are free of debris and properly functioning. Reserve funding recommended for regular cycles of seal coat and local areas of repair every 5 to 7 years.

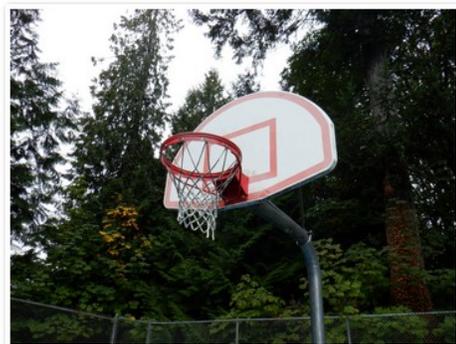
Recreation - Basketball Assembly: Replace

Condition: Good

Good condition with no unusual deterioration or damage. We recommend funding for replacement of the assembly to ensure functionality.

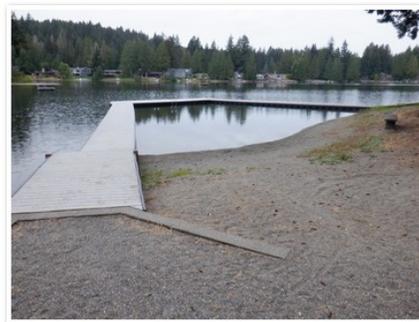
Site/Grounds - Dock, Main Recreation: Replace,

Location: Main Recreation
 Quantity: 425 Square Feet
 UL: 25
 RUL: 19
 Current Cost: \$115,000
 Condition: Good
 Funding Basis: Funded based on current condition

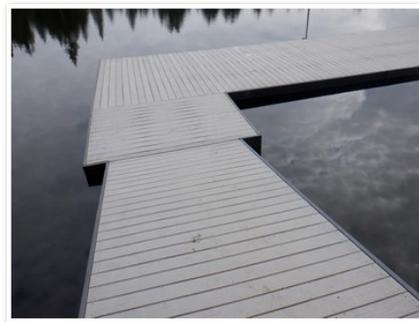
Recreation - Dock, West Side: Maintenance

Location: West Side Park
 Quantity: 1 Allowance
 RUL: 1
 Current Cost: \$15,000
 Condition: Assorted Condition
 Funding Basis: Funded based on Association direction

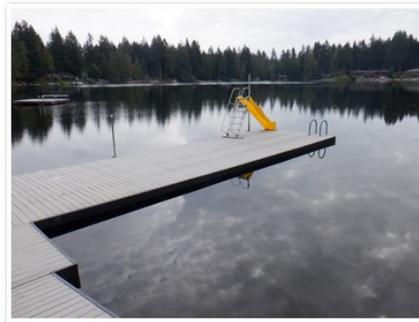
Site/Grounds - Dock, West Side: Replace

Location: West Side Park
 Quantity: 220 Square Feet
 UL: 25
 RUL: 19
 Current Cost: \$59,400
 Condition: Good
 Funding Basis: Funded based on current condition

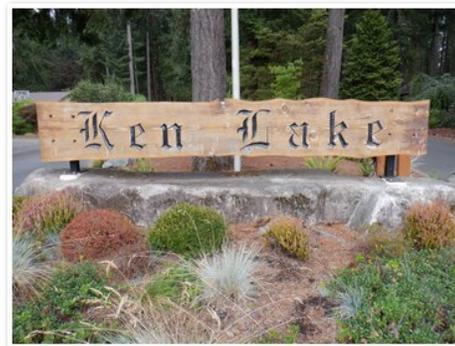
Site/Grounds - Entry Signs: Repair/Replace

Condition: Good

Good condition of wood signs. These units need to be painted regularly to maximize the life expectancy. Reserve funding recommended.

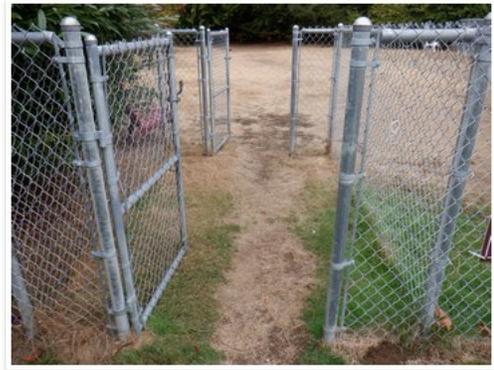
Site/Grounds - Fence: Chainlink, Replace

Condition: Good

Good condition of chain link fencing. Indications are that this fencing is Association responsibility. We suggest planning for eventual replacement.

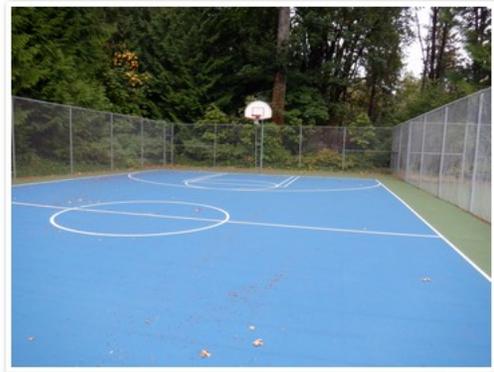
Site/Grounds - Fence: Chainlink, Replace Basket Ball Court

Condition: Good

Good condition of chain link fencing. Indications are that this fencing is Association responsibility. We suggest planning for eventual replacement.

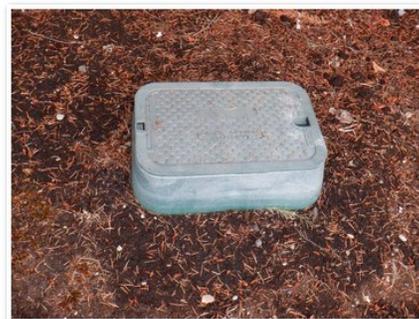
Site/Grounds - Irrigation System: Repair

Location: Tot Lot & West Side
 Quantity: 1 Allowance
 UL: 5
 RUL: 2
 Current Cost: \$12,000
 Condition: Assorted Condition
 Funding Basis: Funded for repair

Fair condition with no reported problems at this time. We suggest including irrigation maintenance within the Association's annual landscape budget/contract, such as select sprinkler head replacements. As the community and irrigation lines age, local areas of line replacement may be needed and generally is not covered by the landscape contract. At this time there is no expectation of total line replacement, however, we have included an allowance for partial repair/replacement every few years. As these expenses occur and trends are developed update the reserve funding as needed.

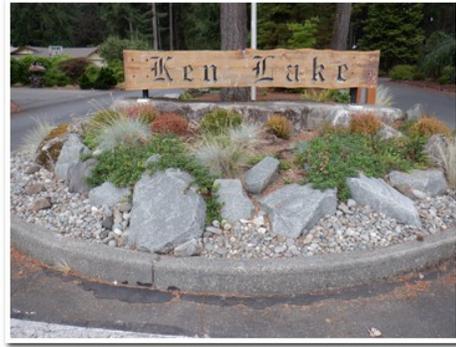
Site/Grounds - Landscaping: Refurbish

Location: Various
Quantity: 1 Allowance
UL: 4
RUL: 1
Current Cost: \$5,900
Condition: Good
Funding Basis: Funded based on the typical life expectancy

This component may be used to fund large landscape projects not budgeted within the Operating Budget. This expense may vary greatly depending on the desires of the Board. We suggest starting with an allowance every couple of years to complete cycles of refurbishment such as replanting's, bark mulch etc.

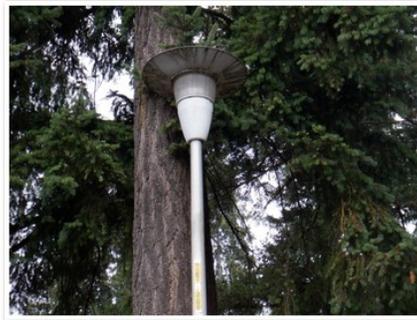
Site/Grounds - Lights: Pole, Replace

Location: Throughout
Current Cost:
Condition: Functional
Funding Basis: Unfunded, not Association responsibility

We understand that the pole lights throughout the Association and adjacent to the streets/sidewalks are the responsibility of the Public Utility, not the Association. Therefore, no reserve funding is required.

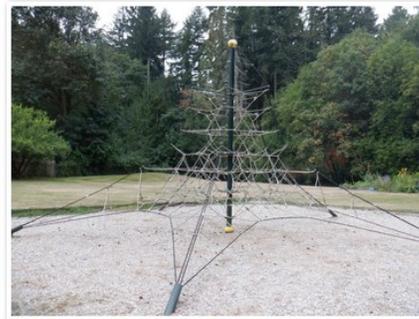
Recreation - Play Equipment: Rope Dome Replacement

Quantity: 1 Unit
 UL: 25
 RUL: 12
 Current Cost: \$26,700
 Condition: Good
 Funding Basis: Funded based on the typical life expectancy

Good condition with no structural instability or unusual deterioration noted during our inspection. Inspect regularly and refurbish fall zones and repair as needed utilizing the operating budget. Reserve funding recommended.

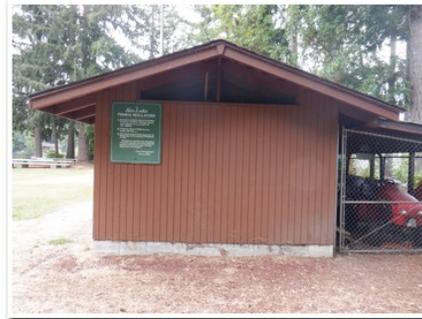
Building - Shed: Repair Allowance

Quantity: 1 Allowance
 UL: 8
 RUL: 2
 Current Cost: \$5,630
 Condition: Fair
 Funding Basis: Funded for repair

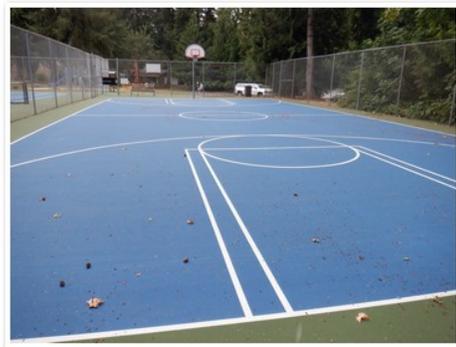
Site/Grounds - Sport Court: Resurface

Location: Ballfield Park
 Quantity: 1 Allowance
 UL: 15
 RUL: 9
 Current Cost: \$13,000
 Condition: Good
 Funding Basis: Funded based on the typical life expectancy

Last done in 2017.

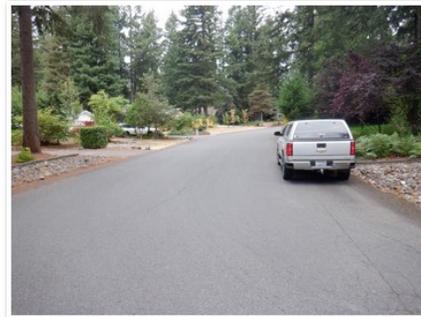
Site/Grounds - Streets

Condition: Assorted Condition

We understand that the streets have been transferred to the Public so there is no Association responsibility.
