# Reserve Study Level II

Prepared for Lakemoor Community Club  
2026 Fiscal Year

Prepared by CEDCORE, LLC  
Version 3  
© 2026 CEDCORE, LLC

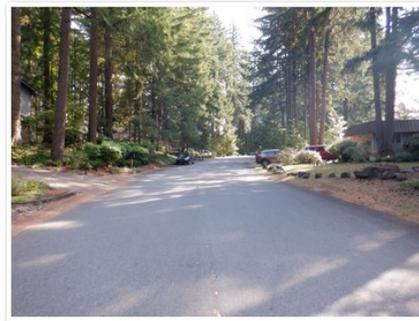
**Site/Grounds - Asphalt: Resurface**

Location: Christopher Park  
 Quantity: 11522 Square Feet  
 UL: 50  
 RUL: 0  
 Current Cost: \$40,300  
 Condition: Functional  
 Funding Basis: Funded based on current condition

Area reduced to reflect the area that was rebuilt by the City of Olympia in Oct 2022.

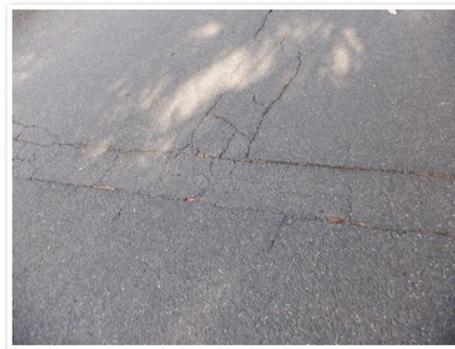
**Site/Grounds - Asphalt: Sealcoat, Crack Filling and Patching**

Location: Christopher Park  
 Quantity: 11522 Square Feet  
 UL: 10  
 RUL: 0  
 Current Cost: \$6,880  
 Condition: Assorted Condition  
 Funding Basis: Funded based on the typical life expectancy

Generally fair condition of asphalt surface with some localized areas that are dry and faded. We recommend regular seal cycles be completed to maximize the life of asphalt. Seal coat and crack filler protects against damaging elements, such as oil, water, UV, etc. As routine maintenance ensure that oil spills are promptly cleaned and drains and grates are free of debris and properly functioning. Reserve funding recommended for regular cycles of seal coat and local areas of repair every 5 to 7 years.

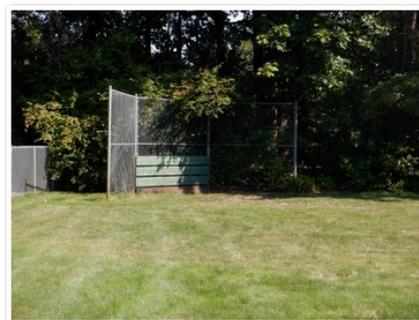
**Recreation - Ballfield Park: Refurbish**

Location: Ballfield Park  
 Quantity: 1 Allowance  
 UL: 10  
 RUL: 2  
 Current Cost: \$2,500  
 Condition: Good  
 Funding Basis: Funded based on Association direction

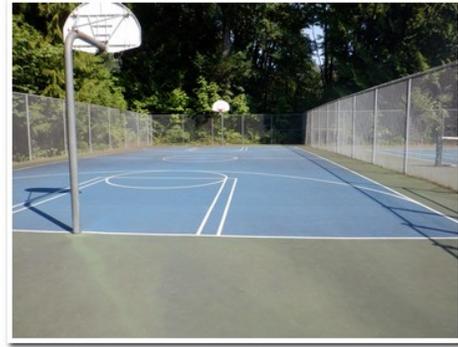
**Recreation - Basketball Assembly: Replace**

Location: Ballfield Park  
 Quantity: 2 Each  
 UL: 15  
 RUL: 4  
 Current Cost: \$3,400  
 Condition: Good  
 Funding Basis: Funded based on the typical life expectancy

Good condition with no unusual deterioration or damage. We recommend funding for replacement of the assembly to ensure functionality.

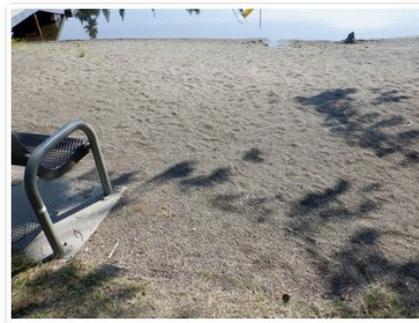
**Site/Grounds - Beach, Sand: Replenish**

Quantity: 1 Allowance  
 UL: 4  
 RUL: 1  
 Current Cost: \$650  
 Condition: Assorted Condition

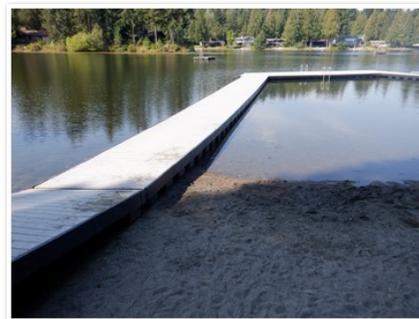
**Site/Grounds - Dock, Main Recreation: Replace,**

Location: Main Recreation  
 Quantity: 425 Square Feet  
 UL: 25  
 RUL: 16  
 Current Cost: \$132,000  
 Condition: Good  
 Funding Basis: Funded based on current condition

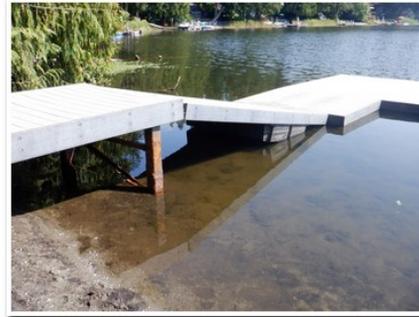
**Recreation - Dock, West Side: Maintenance/Repair**

Location: West Side Park  
 Quantity: 1 Allowance  
 UL: 20  
 RUL: 19  
 Current Cost: \$32,000  
 Condition: Assorted Condition  
 Funding Basis: Funded based on Association direction

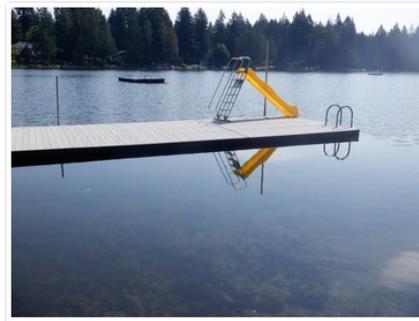
### Site/Grounds - Dock, West Side: Replace

Location: West Side Park  
 Quantity: 220 Square Feet  
 UL: 25  
 RUL: 16  
 Current Cost: \$55,000  
 Condition: Good  
 Funding Basis: Funded based on current condition

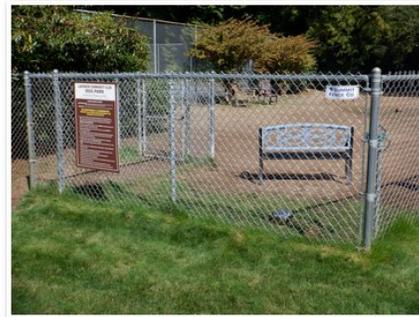
### Site/Grounds - Dog Park: Refurbish

Quantity: 1 Allowance  
 UL: 4  
 RUL: 0  
 Current Cost: \$1,030  
 Condition: Assorted Condition

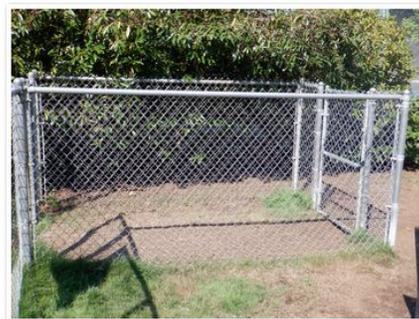
### Site/Grounds - Dog Park: Repairs

Quantity: 1 Allowance  
 UL: 30  
 RUL: 22  
 Current Cost: \$2,000  
 Condition: Good  
 Funding Basis: Funded based on the typical life expectancy

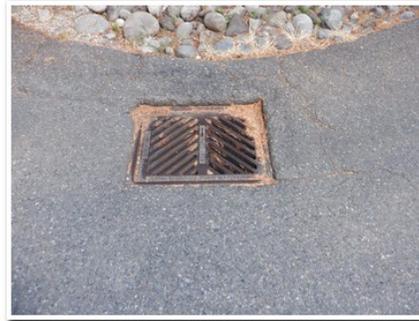
## Site/Grounds - Drainage

Location: Throughout  
 Current Cost:  
 Condition: Unknown  
 Funding Basis: Unfunded, operating expense

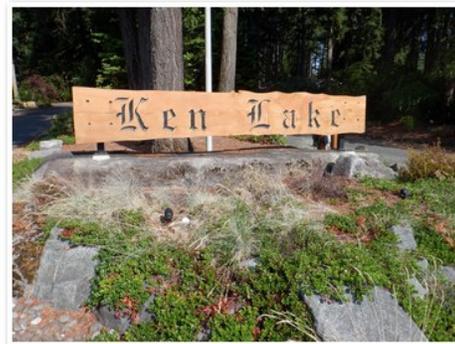
## Site/Grounds - Entry Signs: Repair/Replace

Location: Entrance  
 Quantity: 1 Allowance  
 UL: 25  
 RUL: 13  
 Current Cost: \$12,200  
 Condition: Good  
 Funding Basis: Funded based on the typical life expectancy

Good condition of wood signs. These units need to be painted regularly to maximize the life expectancy. Reserve funding recommended.

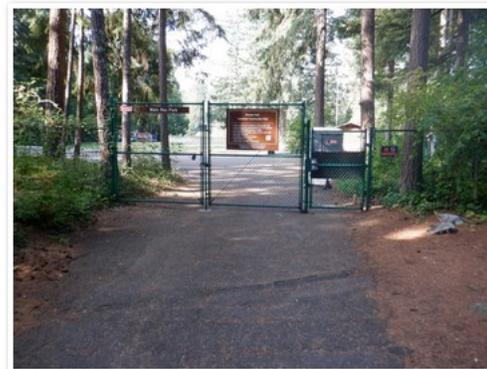
## Site/Grounds - Fence: Chainlink, Replace

Location: Christopher Park & Ballfield Park & West Side Park  
 Quantity: 588 Linear Feet  
 UL: 30  
 RUL: 6  
 Current Cost: \$19,100  
 Condition: Good  
 Funding Basis: Funded based on the typical life expectancy

Good condition of chain link fencing. Indications are that this fencing is Association responsibility. We suggest planning for eventual replacement.

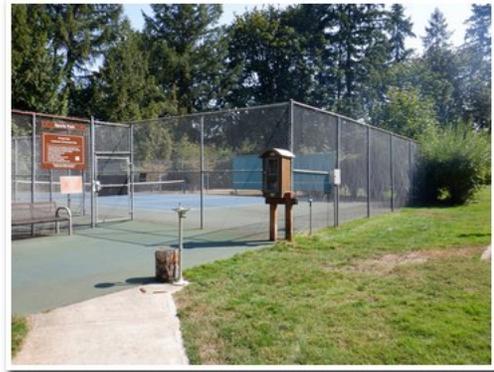
## Site/Grounds - Fence: Chainlink, Replace Basket Ball Court

Good condition of chain link fencing. Indications are that this fencing is Association responsibility. We suggest planning for eventual replacement.

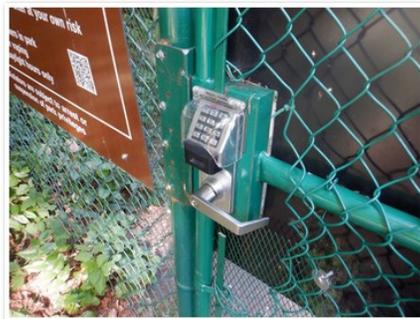
### Site/Grounds - Gate Lock: Replace

Condition: Good

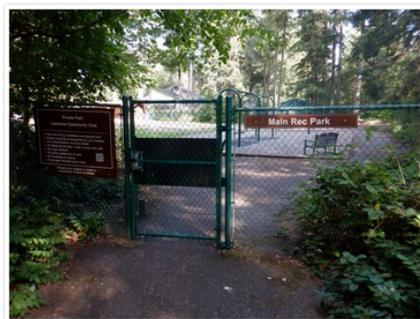
### Site/Grounds - Gates, Pedestrian: Replace

Condition: Good

Funding Basis: Unfunded, outside the 30 year scope of report

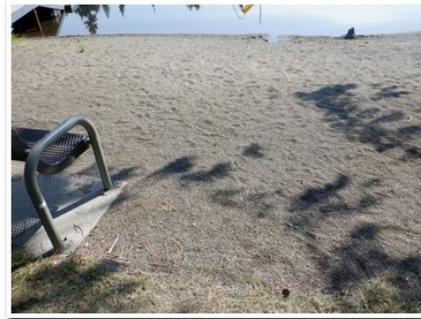
### Site/Grounds - Gravel, Main Rec & Westside: Refurbish

Quantity: 1 Allowance  
 UL: 6  
 RUL: 0  
 Current Cost: \$3,090

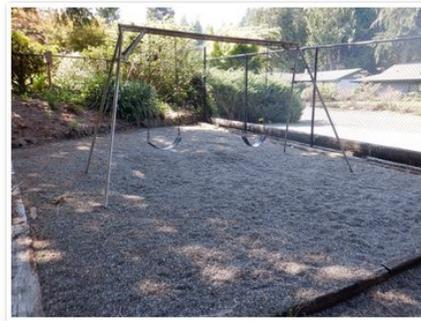
**Site/Grounds - Gravel: Refurbish**

Location: Swing Sets  
 Quantity: 1 Allowance  
 UL: 10  
 RUL: 0  
 Current Cost: \$2,600  
 Condition: Assorted Condition  
 Funding Basis: Unfunded, operating expense

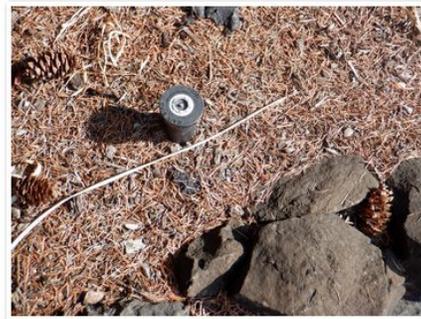
**Site/Grounds - Irrigation System: Repair**

Location: Tot Lot & West Side  
 Quantity: 1 Allowance  
 UL: 6  
 RUL: 0  
 Current Cost: \$13,600  
 Condition: Assorted Condition  
 Funding Basis: Funded for repair

Fair condition with no reported problems at this time. We suggest including irrigation maintenance within the Association's annual landscape budget/contract, such as select sprinkler head replacements. As the community and irrigation lines age, local areas of line replacement may be needed and generally is not covered by the landscape contract. At this time there is no expectation of total line replacement, however, we have included an allowance for partial repair/replacement every few years. As these expenses occur and trends are developed update the reserve funding as needed.

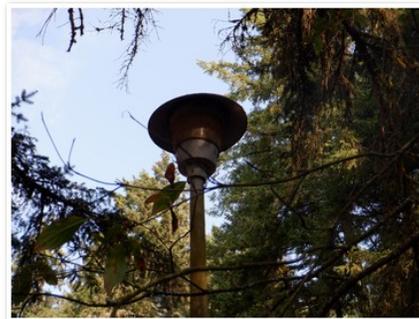
**Site/Grounds - Lights: Pole, Replace**

Current Cost:  
 Condition: Functional  
 Funding Basis: Unfunded, not Association responsibility

We understand that the pole lights throughout the Association and adjacent to the streets/sidewalks are the responsibility of the Public, not the Association. Therefore, no reserve funding is required.

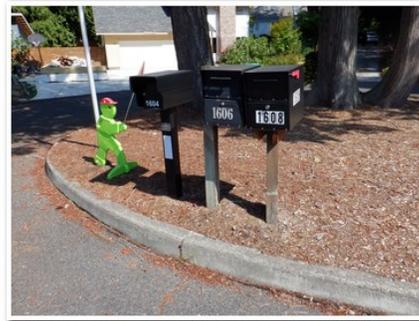
**Site/Grounds - Mailbox Individual: Replace**

Current Cost:  
 Condition: Assorted Condition  
 Funding Basis: Unfunded, not Association responsibility

Fair condition of mailboxes with no unusual damage observed. Clean as needed to maintain appearance. Oil hinges to maintain ease of operation. We suggest planning for eventual replacement of the mailboxes to ensure functionality and community aesthetics.

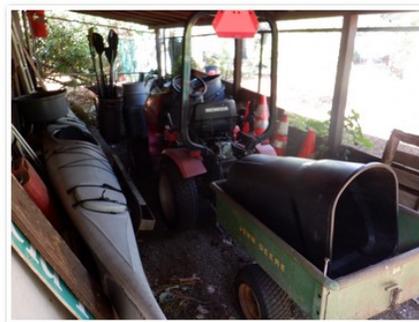
**Mechanical & Equipment - Mower: Replace**

Quantity: 1 Unit  
 UL: 12  
 RUL: 0  
 Current Cost: \$13,800  
 Condition: Unknown  
 Funding Basis: Funded based on the typical life expectancy

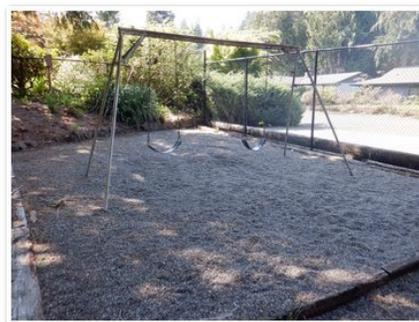
**Recreation - Pea Gravel, Swing Sets: West Side, Replace**

Location: West Side Park  
 Current Cost:  
 Funding Basis: Unfunded, not Association responsibility

Planned for spring 2023. Work to be done by City.

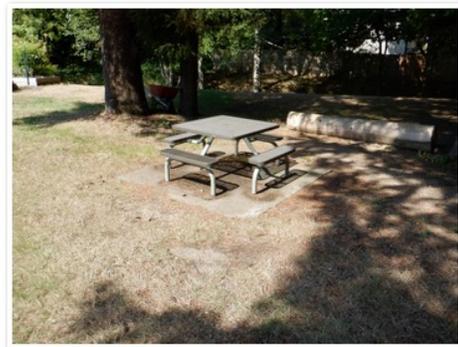
### Recreation - Picnic Table

Location: Tot Lot  
 Quantity: 1 Allowance  
 UL: 20  
 RUL: 13  
 Current Cost: \$7,900  
 Condition: Excellent  
 Funding Basis: Funded based on the typical life expectancy

This component also includes 3 large Alaskan Cedar tables in Christopher Park/AKA Main Rec park.

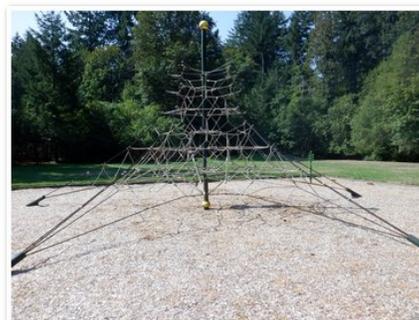
### Recreation - Play Equipment: Rope Dome Replacement

Quantity: 1 Each  
 UL: 25  
 RUL: 9  
 Current Cost: \$30,300  
 Condition: Good  
 Funding Basis: Funded based on the typical life expectancy

Good condition with no structural instability or unusual deterioration noted during our inspection. Inspect regularly and refurbish fall zones and repair as needed utilizing the operating budget. Reserve funding recommended.

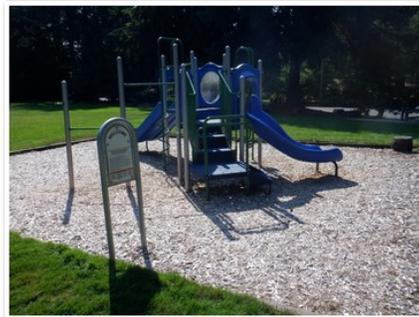
### Recreation - Play Structure: BallField

Location: BallField  
 Quantity: 1 Each  
 UL: 25  
 RUL: 16  
 Current Cost: \$11,300  
 Condition: Good  
 Funding Basis: Funded based on Association direction

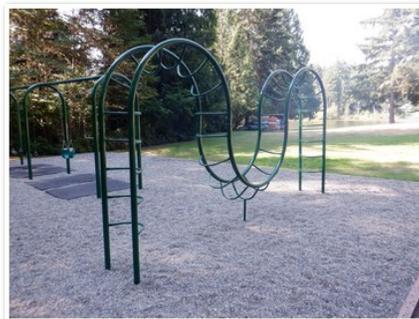
### Recreation - Play Structure: Main Recreation

Location: Main Recreation  
 Quantity: 1 Each  
 UL: 25  
 RUL: 21  
 Current Cost: \$11,300  
 Condition: Unknown  
 Funding Basis: Funded based on Association direction

Installed in 2022.

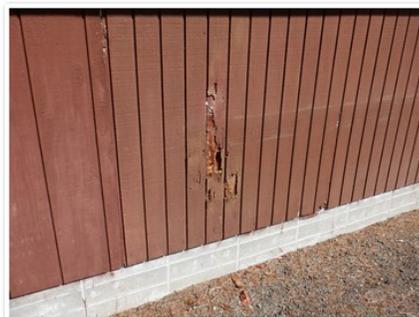
### Building - Shed: Repair Allowance

Quantity: 1 Allowance  
 UL: 9  
 RUL: 0  
 Current Cost: \$6,400  
 Condition: Fair  
 Funding Basis: Funded for repair

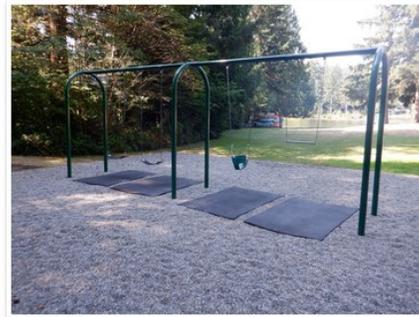
**Recreation - Swing Set Toy Structure: Replace**

Location: Tot Lot  
 Quantity: 1 Unit  
 UL: 25  
 RUL: 21  
 Current Cost: \$16,700  
 Funding Basis: Funded based on Association records

\$12k worth was installed in 2012 and \$4k for swings back in 1980 and \$2500 swings safety surface, swings installed at tot lot park in 2009 for \$10k= \$28,500

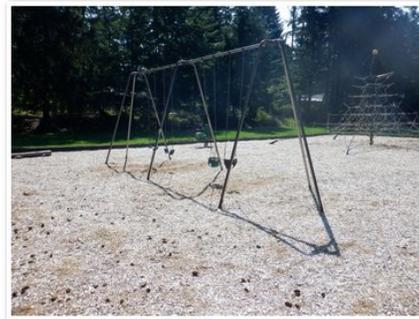
**Recreation - Swing Sets: Tot Lot, Replace**

Location: Tot Lot  
 Quantity: 3 Units  
 UL: 25  
 RUL: 21  
 Current Cost: \$13,600  
 Funding Basis: Funded based on Association records

Three small play structures to be installed in 2023.

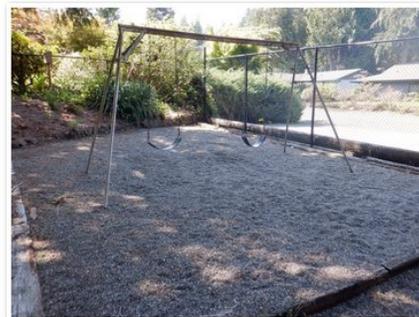
**Recreation - Swing Sets: West Side Park, Replace**

Location: West Side Park  
 Quantity: 1 Unit  
 UL: 25  
 RUL: 7  
 Current Cost: \$11,300  
 Condition: Functional  
 Funding Basis: Funded based on Association records
